**Flood Control Project Maintenance  
Levee Inspections**  
**LMA District Cover Sheet**  
**Spring 2020 Levee Inspection Results**

**Merced Streams Group**

**Spring 2020 Levee Inspection Results**

Waterway			Bank	Unit Miles
Unit No. 01 Black Rascal Diversion			Right	1.61
	Spring (March - May)	Summer (June - August)	(September - November) Fall	Winter (December - February)
Unit Maintenance Rating (Fall Only)				
Date of Inspection	4/16/2020 - 4/16/2020			
DWR Inspector	Corey Fujitani			
Accompanied By	Oscar Ortiz Merced County

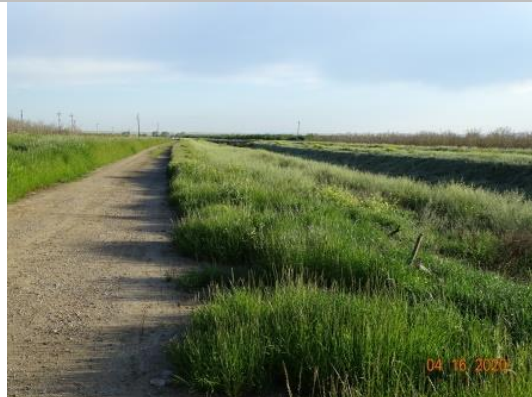
Photo 1 of 1 : SP\_2020\_NA0013\_331\_2\_20200504\_00015.jpg

LM Start	0.01	Rating **	U	Issue No.	2
LM End	1.61	Issue Type +	Ma	Location *	WS
Category	Earthen Levee			GPS Latitude/Longitude	
				Start	End
Item	Vegetation			37.314819 °	37.337083 °
				-120.396382 °	-120.396560 °
DWR ID	DWR_NA0013_01_f_2019_2				
Comment Code					
V1 : Control annual grass and weeds on the levee slopes and easements.					
Inspector Comment					
Control vegetation and remove thorny bushes growing at LM 1.45 to 1.61

Looking upstream along the waterside slope. (Spring 2020)

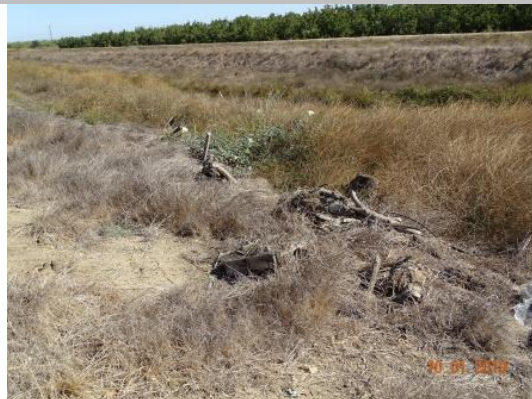
Photo 1 of 1 : SP\_2020\_NA0013\_331\_11\_20200225\_00006.jpg

LM Start	0.02	Rating **	M	Issue No.	11
LM End	0.02	Issue Type +	Ma	Location *	WS
Category	Earthen Levee			GPS Latitude/Longitude	
				Start	End
Item	Encroachments			37.314942 °	37.314942 °
				-120.396394 °	-120.396394 °
DWR ID	DWR_NA0013_01_f _ 2018_11				
Comment Code					
DE : Debris					
Inspector Comment					
There is garbage on the waterside slope.

Debris and garbage on waterside slope. (Fall 2019)

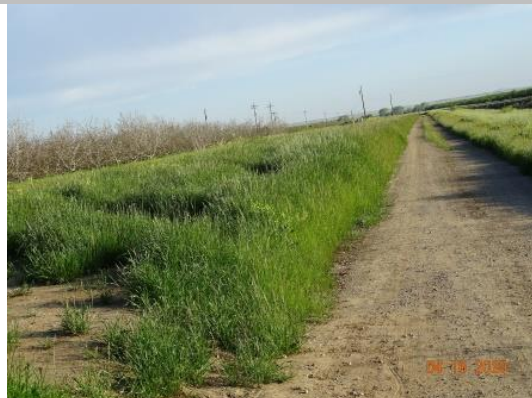
Photo 1 of 1 : SP\_2020\_NA0013\_331\_7\_20200505\_00016.jpg

LM Start	0.02	Rating **	U	Issue No.	7
LM End	0.43	Issue Type +	Ma	Location *	LS
Category	Earthen Levee			GPS Latitude/Longitude	
				Start	End
Item	Vegetation			37.314966 °	37.320765 °
				-120.396398 °	-120.396617 °
DWR ID	DWR_NA0013_01_s_2020_7				
Comment Code					
V1 : Control annual grass and weeds on the levee slopes and easements.					
Inspector Comment					
end at olive ave

View of vegetation growing on the landside slope. (Spring 2020)

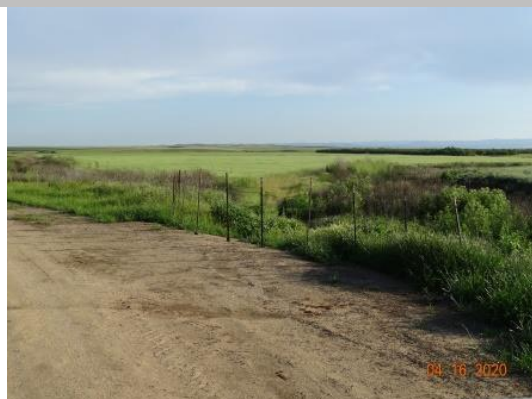
Photo 1 of 1 : SP\_2020\_NA0013\_331\_18\_20200505\_00020.jpg

LM Start	1.27	Rating **	M	Issue No.	18
LM End	1.27	Issue Type +	En	Location *	WS
Category	Earthen Levee			GPS Latitude/Longitude	
				Start	End
Item	Encroachments			37.332554 °	37.332554 °
				-120.394767 °	-120.394767 °
DWR ID	DWR_NA0013_01_s_2019_18				
Comment Code					
RA : Ramp					
Inspector Comment					
Ramp has been fenced off at waterside shoulder.

View of ramp on waterside slope looking Northeast. (Spring 2020)

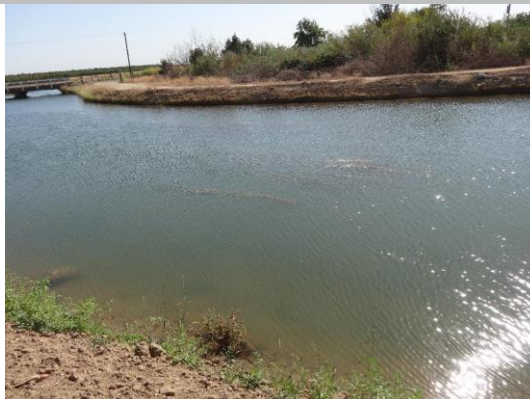
Photo 1 of 3 : UCIP\_SP\_2020\_41672\_35211.jpg

Comment Code						
Inspector Comment						
DS_ID:23079 FS_ID:41672 EP_NO: N/A Repair Type: Non-Urgent Crossing Status: Indicator Found UCIP Comments: 09/17/2013 Verify Pipe is abandoned or still intact.- may be this crossing was abandoned/removed during recent levee reconstruction.- no signs of pipe and appurtenances on waterside.- only a CM pipe riser with slide gate found on landside. (DWR UCIP - P. Amatya) FIELD_STRUCT_DESC: 36-inch corrugated metal irrigation pipe through the levee, 10 feet below the crown. Riser on the landside (LS). Screw gate in a 48-inch pipe well on the waterside (WS) slope. Concrete headwall and cobble spillway at the LS toe. Concrete headwall at the WS toe. [Additional Reference(s): USACE San Joaquin O&M Manual 607, June 1962, (HLM 1.32)]. FS Date: 9/17/2013

WS view: no signs of pipe and appurtenances on levee slope and channel bank.

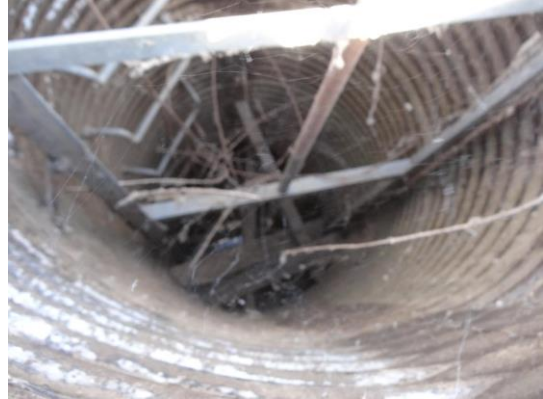
Photo 3 of 3 : UCIP\_SP\_2020\_41672\_35209.jpg

LS view: inside view of CM pipe riser with slide gate.

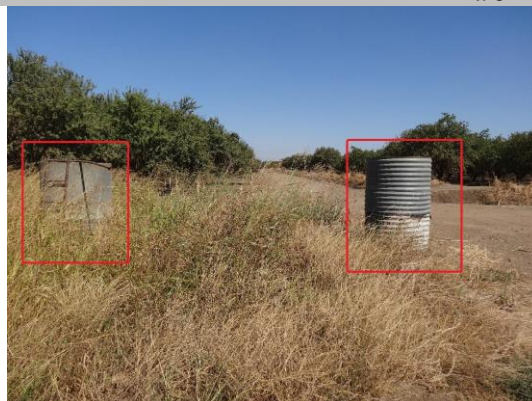
Photo 1 of 3 : UCIP\_SP\_2020\_21263\_35761.jpg

LM Start	0.01	Rating **	M	Issue No.	32
LM End	0.01	Issue Type +	En	Location *	
Category	Supplemental			GPS Latitude/Longitude	
				Start	End
Item	DWR UCIP Field Study			37.337019 °	37.337019 °
				-120.387539 °	-120.387539 °
DWR ID	23052				
Comment Code					
Inspector Comment					
DS_ID:23052 FS_ID:21263 EP_NO: N/A Repair Type: Non-Urgent Crossing Status: Found UCIP Comments: 09/17/2013 - needs more investigations on this crossing. - new water filtration plant on LS with pump and concrete vault.- a concrete standpipe and CM pipe riser on WS. (DWR UCIP - P. Amatya) FIELD_STRUCT_DESC: 10-inch steel irrigation pipe through the levee, 5 feet below the crown. Riser on the landside (LS). Screw gate in a 36-inch pipe well on the waterside (WS) slope. [Additional Reference(s): DWR Levee Log, 2005. USACE San Joaquin O&M Manual 607, June 1962, (HLM 0.00)]. FS Date: 9/17/2013

WS view: concrete standpipe (left) and CMP standpipe (right).

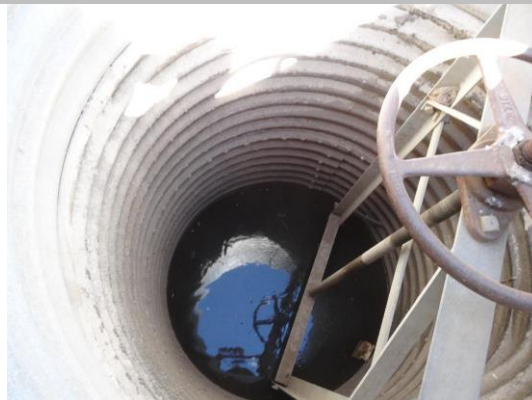
Photo 2 of 3 : UCIP\_SP\_2020\_21263\_35760.jpg

WS view: inside view of CMP standpipe with slide gate.

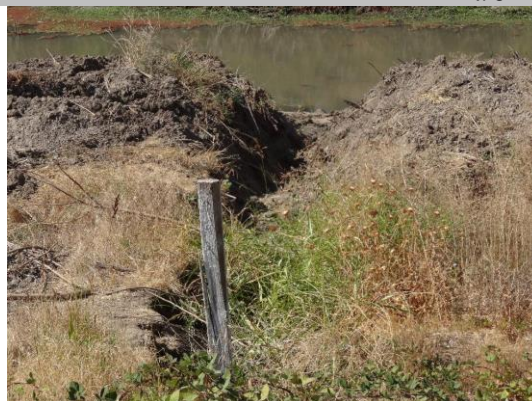
Photo 1 of 3 : UCIP\_SP\_2020\_50156\_35245.jpg

DS\_ID:23053  
FS\_ID:50156  
EP\_NO: N/A  
Repair Type: No Action Needed  
Crossing Status: Found  
UCIP Comments: 08/23/2016: LS inlet is clear. WS gate has been cleared of vegetation and functions properly. Crossing has been downgraded from Urgent to No Action Needed. (K. Fazel - UCIP)09/17/2013:- needs vegetation cleaning on both sides.- flap gate was not closed during field survey.- inlet needs cleaning. (P. Amatya - UCIP)  
FIELD\_STRUCT\_DESC: 24-inch corrugated metal gravity drainage pipe through the levee, 8 feet below the crown. Concrete headwall, flap gate, and concrete grouted cobble spillway on the waterside (WS) toe. Concrete headwall on the landside (LS) toe. [Additional Reference(s): DWR Levee Log, 2005. USACE San Joaquin O&M Manual 607, June 1962, (HLM 0.29)].  
FS Date: 8/23/2016

WS view: cobble spillway and channel on waterside.

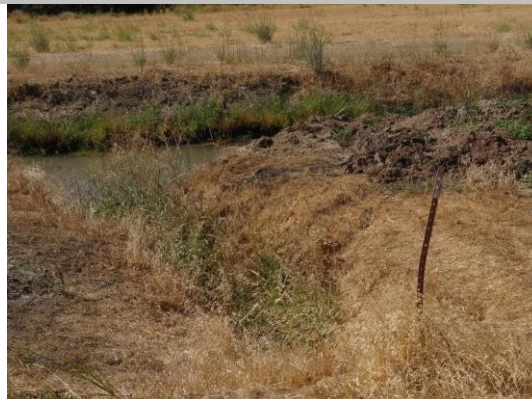
Photo 1 of 3 : UCIP\_SP\_2020\_20946\_35266.jpg

LM Start	0.54	Rating **	M	Issue No.	34
LM End	0.54	Issue Type +	Ma	Location *	
Category	Supplemental			GPS Latitude/Longitude	
				Start	End
Item	DWR UCIP LMA Responsibility			37.333180 °	37.333180 °
				-120.394069 °	-120.394069 °
DWR ID	23054				
Comment Code					
Inspector Comment					
DS_ID:23054 FS_ID:20946 EP_NO: N/A Repair Type: Non-Urgent Crossing Status: Found UCIP Comments: 09/17/2013 - needs vegetation cleaning on both sides.- flap gate was not properly closed during field survey.- inlet needs cleaning. (DWR UCIP - P. Amatya) FIELD_STRUCT_DESC: 24-inch corrugated metal gravity drainage pipe through the levee, 12 feet below the crown. Concrete headwall, flap gate, and concrete grouted cobble spillway on the waterside (WS) toe. Concrete headwall on the landside (LS) toe. [Additional Reference(s): DWR Levee Log, 2005]. FS Date: 9/17/2013

WS view: cobble spillway and channel on waterside.

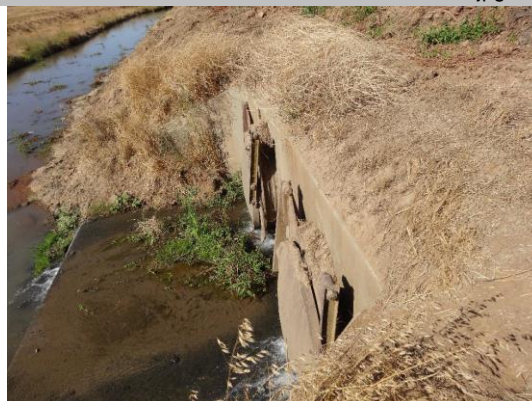
Photo 1 of 3 : UCIP\_SP\_2020\_20965\_35292.jpg

LM Start	0.90	Rating **	A/W	Issue No.	36	
LM End	0.90	Issue Type +	Ma	Location *		
Category	Supplemental			GPS Latitude/Longitude		
				Start		End
Item	DWR UCIP LMA Responsibility			37.328283 °	37.328283 °	
				-120.396074 °	-120.396074 °	
DWR ID	23056					
Comment Code						
Inspector Comment						
DS_ID:23056 FS_ID:20965 EP_NO: N/A Repair Type: No Action Needed Crossing Status: Found UCIP Comments: 09/17/2013 - working during field inspection.- vegetation on drainage ditch/channel (DWR UCIP - P. Amatya) FIELD_STRUCT_DESC: 1 of 2: 60-inch corrugated metal gravity drainage pipe through the levee, 10 feet below the crown. Concrete headwall and flap gate on the waterside (WS) berm, 5 feet from the levee toe. Concrete headwall on the landside (LS) toe. [Additional Reference(s): DWR Levee Log, 2005. USACE San Joaquin O&M Manual 607, June 1962, (HLM 0.91)]. FS Date: 9/17/2013

WS view: two 60" CMPs, flap gates, and headwall on channel bank.

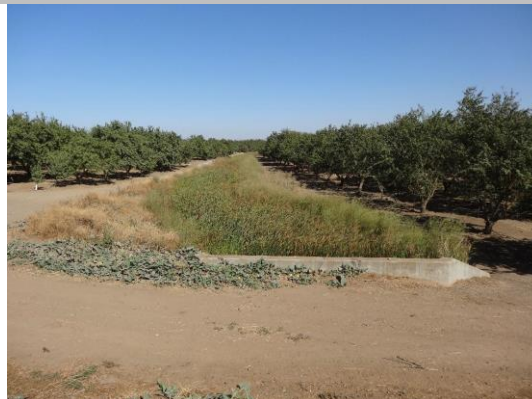
Photo 2 of 3 : UCIP\_SP\_2020\_20965\_35291.jpg

LS view: headwall on levee toe. Green vegetation in drainage channel.

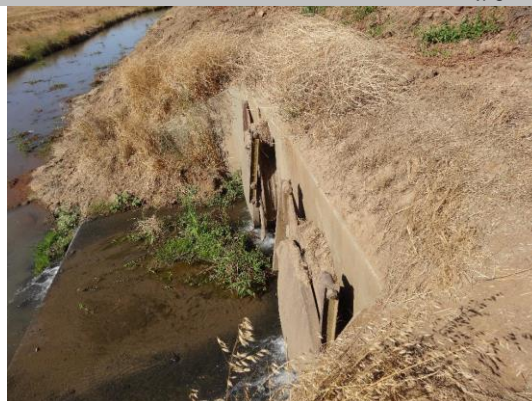
Photo 1 of 3 : UCIP\_SP\_2020\_20983\_35302.jpg

LM Start	0.91	Rating **	A/W	Issue No.	37	
LM End	0.91	Issue Type +	Ma	Location *		
Category	Supplemental			GPS Latitude/Longitude		
				Start		End
Item	DWR UCIP LMA Responsibility			37.328267 °		37.328267 °
				-120.396084 °		-120.396084 °
DWR ID	23080					
Comment Code						
Inspector Comment						
DS_ID:23080 FS_ID:20983 EP_NO: N/A Repair Type: No Action Needed Crossing Status: Found UCIP Comments: 09/17/2013 It was working during field inspection.  Dense vegetation in drainage ditch (DWR UCIP - P. Amatya). FIELD_STRUCT_DESC: 2 of 2: 60-inch corrugated metal gravity drainage pipe through the levee, 10 feet below the crown. Concrete headwall and flap gate on the waterside (WS) berm, 5 feet from the levee toe. Concrete headwall on the landside (LS) toe. [Additional Reference(s): DWR Levee Log, 2005. USACE San Joaquin O&M Manual 607, June 1962, (HLM 0.91)]. FS Date: 9/17/2013

WS view: two CMPs with flap gate, concrete spillway and channel on waterside.

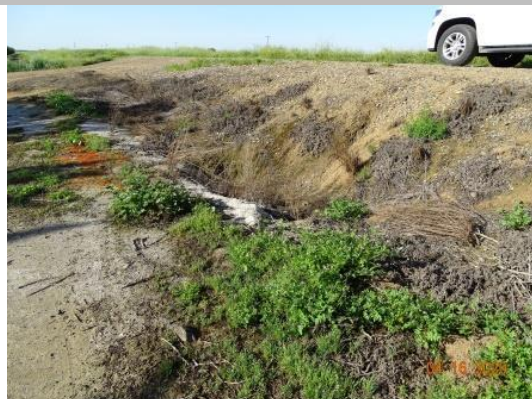
Photo 1 of 1 : SP\_2020\_NA0013\_332\_28\_20200505\_00052.jpg

LM Start	1.29	Rating **	M	Issue No.	28
LM End	1.29	Issue Type +	Ma	Location *	LS
Category	Earthen Levee			GPS Latitude/Longitude	
				Start	End
Item	Erosion / Bank Caving			37.322752 °	37.322752 °
				-120.396030 °	-120.396030 °
DWR ID	DWR_NA0013_02_s_2020_28				
Comment Code					
E1 : Note and monitor erosion site.					
Inspector Comment

Looking downstream at erosion along the landside toe. (Spring 2020)

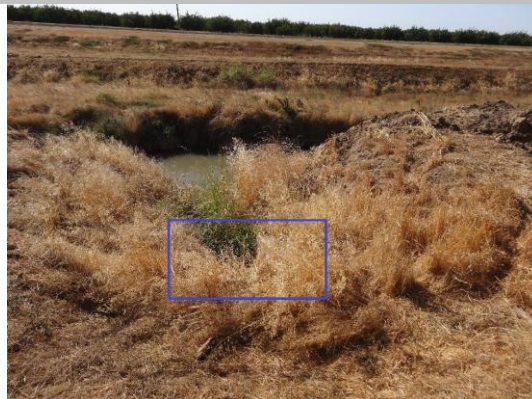
Photo 1 of 3 : UCIP\_SP\_2020\_20984\_35305.jpg

LM Start	1.30	Rating **	A/W	Issue No.	38	
LM End	1.30	Issue Type +	Ma	Location *		
Category	Supplemental			GPS Latitude/Longitude		
				Start		End
Item	DWR UCIP LMA Responsibility			37.322499 °		37.322499 °
				-120.396045 °		-120.396045 °
DWR ID	23057					
Comment Code						
Inspector Comment						
DS_ID:23057						
FS_ID:20984						
EP_NO: N/A						
Repair Type: No Action Needed						
Crossing Status: Found						
UCIP Comments: 09/17/2013 - working during field inspection. (DWR UCIP - P. Amatya)						
FIELD_STRUCT_DESC: 24-inch corrugated metal gravity drainage pipe through the levee, 10 feet below the crown. Concrete headwall, flap gate, and concrete grouted cobble spillway on the waterside (WS) toe. Concrete headwall on the landside (LS) toe. [Additional Reference(s): DWR Levee Log, 2005. USACE San Joaquin O&M Manual 607, June 1962, (HLM 1.32)].						
FS Date: 9/17/2013

WS view: U type concrete headwall and channel on waterside.

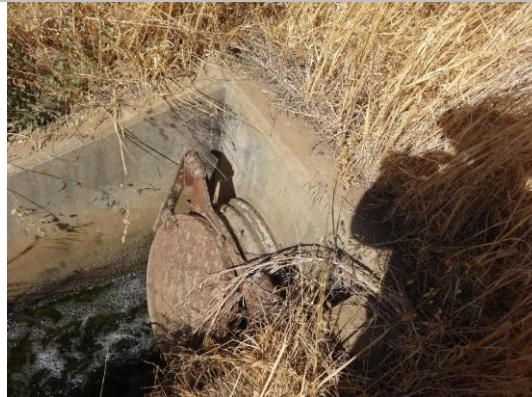
Photo 2 of 3 : UCIP\_SP\_2020\_20984\_35304.jpg

WS view: U typed concrete headwall, CM pipe, and flap gate. It was working during field inspection.

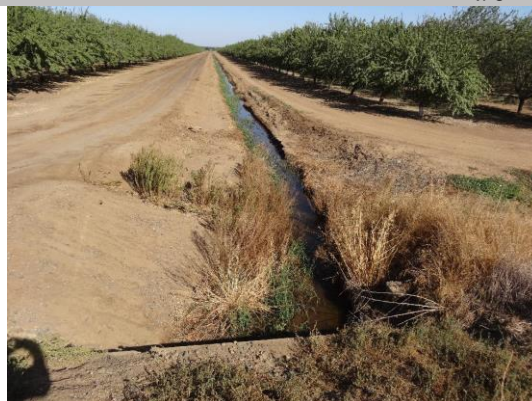
Photo 3 of 3 : UCIP\_SP\_2020\_20984\_35303.jpg

LS view: concrete headwall on levee toe and drainage ditch.

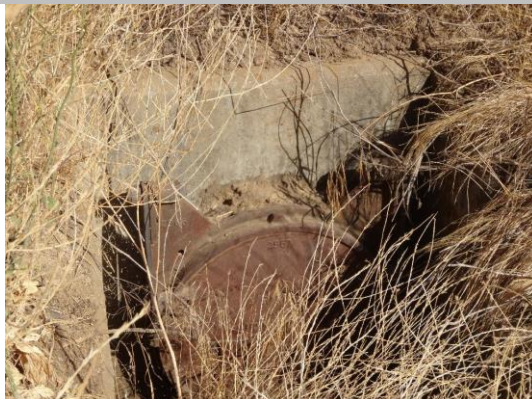
Photo 2 of 3 : UCIP\_SP\_2020\_42993\_35309.jpg

DS\_ID:23058  
 FS\_ID:42993  
 EP\_NO: N/A  
 Repair Type: Non-Urgent  
 Crossing Status: Found  
 UCIP Comments: 09/17/2013 - needs cleaning of debris on spillway on WS. Flapgate blocked by debris on WS. - needs cleaning inside CMP on LS. (DWR UCIP - P. Amatya)  
 FIELD\_STRUCT\_DESC: 24-inch corrugated metal gravity drainage pipe through the levee, 8 feet below the crown. Concrete headwall, flap gate, and concrete grouted cobble spillway on the waterside (WS) toe. Concrete headwall on the landside (LS) toe. [Additional Reference(s): DWR Levee Log, 2005. USACE San Joaquin O&M Manual 607, June 1962, (HLM 1.64)].  
 FS Date: 9/17/2013

WS view: U typed concrete headwall, CM pipe and flap gate. Vegetation and debris need to be cleared.

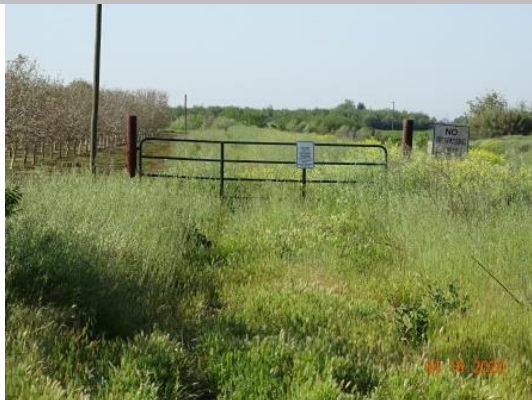
Photo 1 of 1 : SP\_2020\_NA0013\_332\_31\_20200505\_00054.jpg

LM Start	1.62	Rating **	U	Issue No.	31
LM End	1.85	Issue Type +	Ma	Location *	CR
Category	Earthen Levee			GPS Latitude/Longitude	
				Start	End
Item	Vegetation			37.317992 °	37.314609 °
				-120.395735 °	-120.395807 °
DWR ID	DWR_NA0013_02_s_2020_31				
Comment Code					
V9 : Keep the crown roadway free of vegetation.					
Inspector Comment

Looking downstream along the levee crown. (Spring 2020)

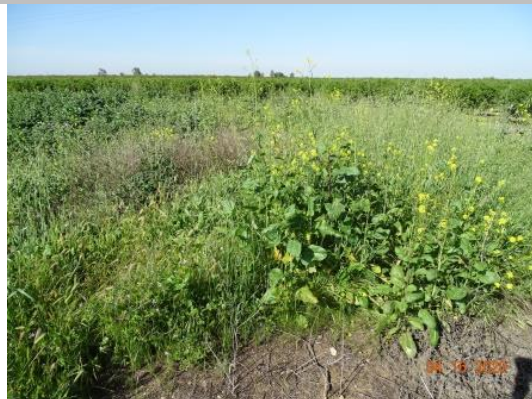
Photo 1 of 1 : SP\_2020\_NA0013\_333\_17\_20200505\_00031.jpg

LM Start	0.00	Rating **	U	Issue No.	17
LM End	0.33	Issue Type +	Ma	Location *	CR
Category	Earthen Levee			GPS Latitude/Longitude	
				Start	End
Item	Vegetation			37.257654 °	37.262387 °
				-120.288501 °	-120.288304 °
DWR ID	DWR_NA0013_03_s_2020_17				
Comment Code					
V1 : Control annual grass and weeds on the levee slopes and easements.					
Inspector Comment

Keep the levee crown free of vegetation. (Spring 2020)

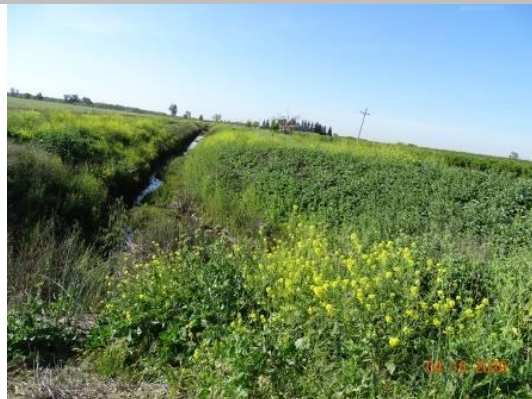
Photo 1 of 1 : SP\_2020\_NA0013\_333\_15\_20200505\_00032.jpg

LM Start	0.00	Rating **	U	Issue No.	15
LM End	0.33	Issue Type +	Ma	Location *	WS
Category	Earthen Levee			GPS Latitude/Longitude	
				Start	End
Item	Vegetation			37.257654 °	37.262388 °
				-120.288501 °	-120.288304 °
DWR ID	DWR_NA0013_03_s_2020_15				
Comment Code					
V1 : Control annual grass and weeds on the levee slopes and easements.					
Inspector Comment					
to the start

View of vegetation on the waterside slope. (Spring 2020)

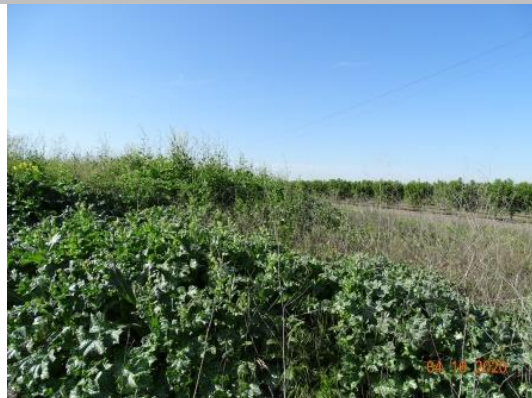
Photo 1 of 1 : SP\_2020\_NA0013\_333\_14\_20200505\_00033.jpg

LM Start	0.00	Rating **	U	Issue No.	14
LM End	0.33	Issue Type +	Ma	Location *	LS
Category	Earthen Levee			GPS Latitude/Longitude	
				Start	End
Item	Vegetation			37.257654 °	37.262390 °
				-120.288501 °	-120.288307 °
DWR ID	DWR_NA0013_03_s_2020_14				
Comment Code					
V1 : Control annual grass and weeds on the levee slopes and easements.					
Inspector Comment					
to the start

Looking downstream along the landside slope. (Spring 2020)

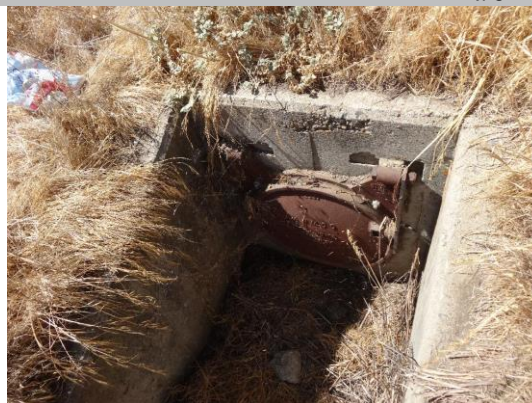
Photo 1 of 3 : UCIP\_SP\_2020\_41815\_35533.jpg

Comment Code					
Inspector Comment					
DS_ID:23060 FS_ID:41815 EP_NO: N/A Repair Type: Non-Urgent Crossing Status: Found UCIP Comments: 09/17/2013 - more than a half of inet pipe burried on LS. - needs vegetation cleaning on both sides.- inlet needs silt removed and cleaning. (DWR UCIP - P. Amaty) FIELD_STRUCT_DESC: 24-inch corrugated metal gravity drainage pipe through the levee, 6 feet below the crown. Concrete headwall, flap gate, and concrete grouted cobble spillway on the waterside (WS) toe. Concrete headwall on the landside (LS) toe. [Additional Reference(s): DWR Levee Log, 2005. USACE San Joaquin O&M Manual 607, June 1962, (HLM 0.18)]. FS Date: 9/17/2013

WS view: U typed concrete headwall, CM pipe, and flap gate.

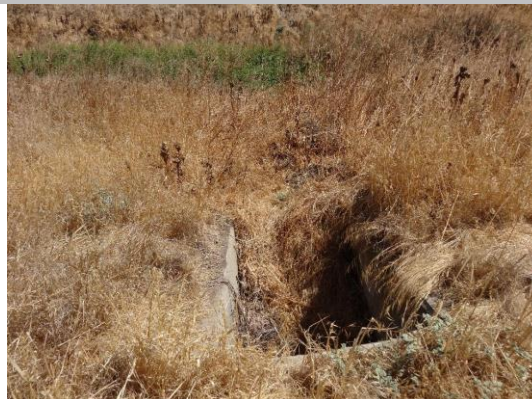
Photo 2 of 3 : UCIP\_SP\_2020\_41815\_35532.jpg

WS view: Silt needs to be removed. Vegetations needs to be cleared.

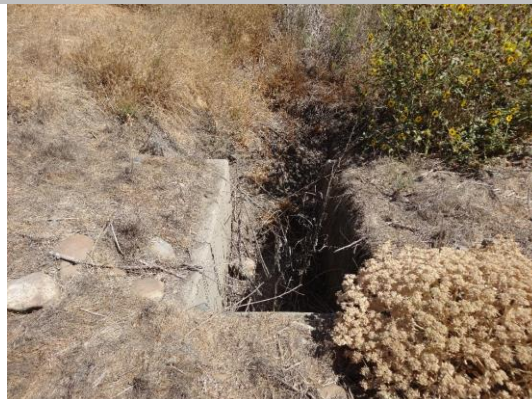
Photo 1 of 3 : UCIP\_SP\_2020\_50144\_35422.jpg

WS view: U typed concrete headwall, cobble spillway, and channel on waterside.

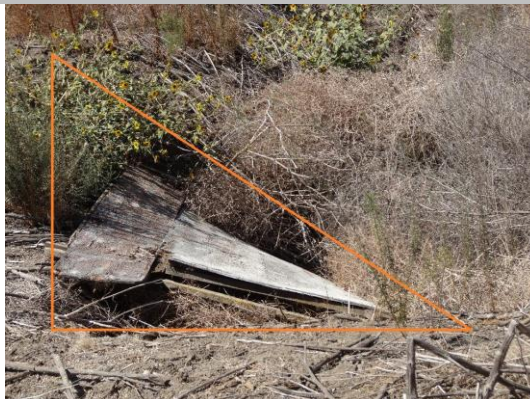
Photo 3 of 3 : UCIP\_SP\_2020\_50144\_35420.jpg

LS view: Debris dumped on inlet structure. Needs to be cleared or abandoned properly.

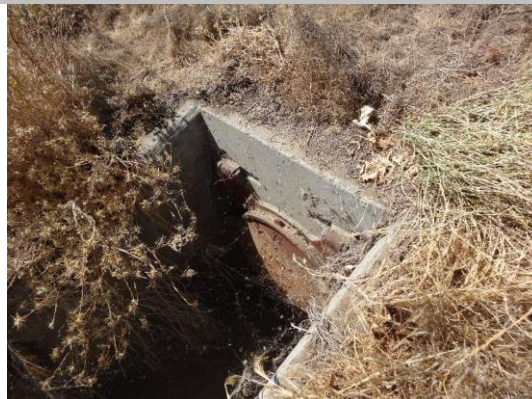
Photo 2 of 3 : UCIP\_SP\_2020\_50149\_35534.jpg

WS view: U typed concrete headwall, CM pipe, and flap gate. Vegetation needs to be cleared.

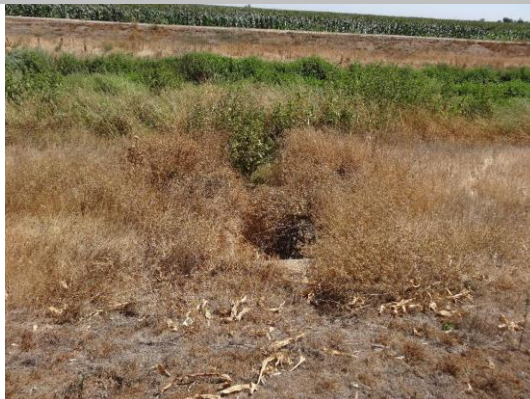
Photo 1 of 3 : UCIP\_SP\_2020\_50151\_35539.jpg

WS view: overview of spillway/outlet area on waterside.

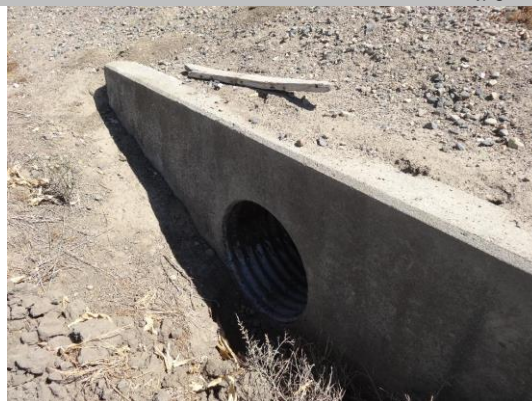
Photo 3 of 3 : UCIP\_SP\_2020\_50151\_35541.jpg

LS view: concrete headwall and CM pipe.

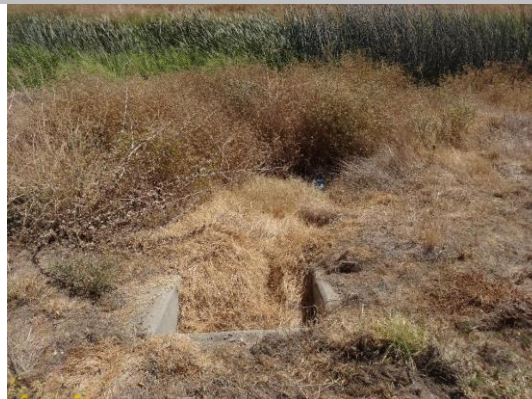
Photo 1 of 3 : UCIP\_SP\_2020\_50152\_35544.jpg

WS view: cobble spillway and channel on waterside.

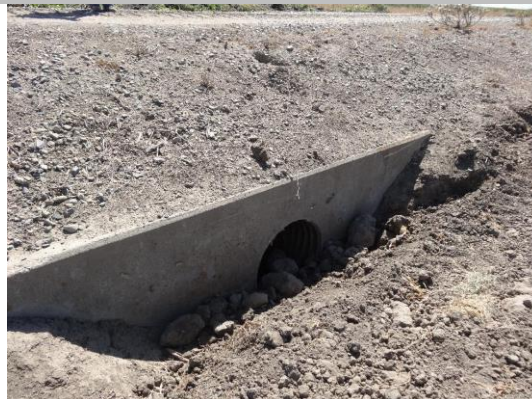
Photo 2 of 3 : UCIP\_SP\_2020\_21063\_35501.jpg

LS view: concrete headwall and CM pipe. Inlet needs clearing.

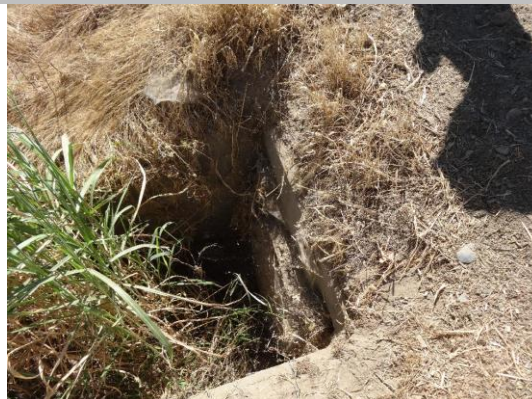
Photo 2 of 3 : UCIP\_SP\_2020\_21064\_35505.jpg

WS view: U typed concrete headwall, CM pipe, and flap gate. Vegetation needs to be cleared.

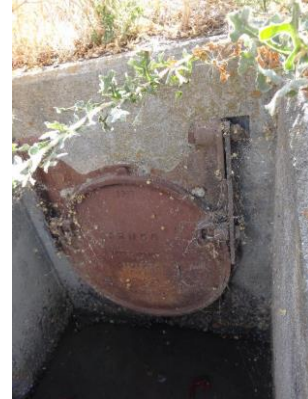
Photo 2 of 3 : UCIP\_SP\_2020\_50148\_35612.jpg

WS view: U typed concrete headwall, CM pipe, and flap gate.

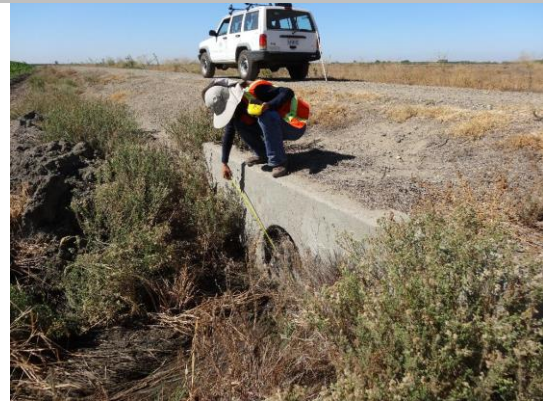
Photo 3 of 3 : UCIP\_SP\_2020\_50148\_35611.jpg

LS view: concrete headwall and CM pipe.

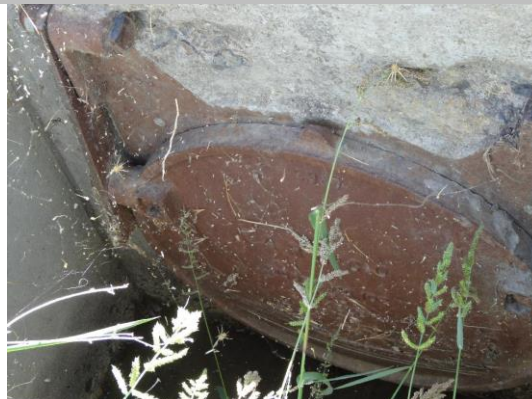
Photo 3 of 3 : UCIP\_SP\_2020\_50155\_35640.jpg

WS view: CM pipe and flap gate. Vegetation needs to be cleared.

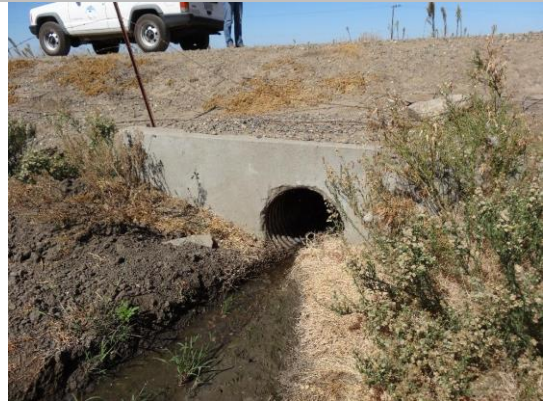
Photo 3 of 3 : UCIP\_SP\_2020\_21126\_35654.jpg

LS view: concrete headwall and CM pipe. Drain pipe was working during field survey.

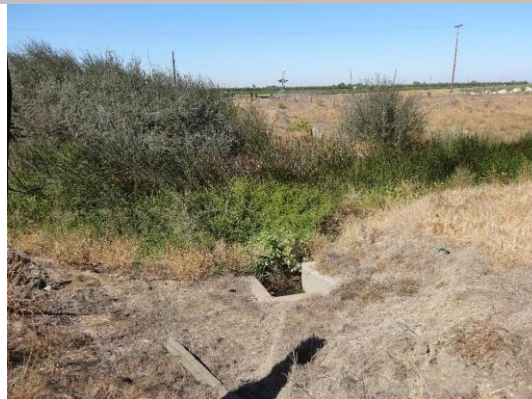
Photo 1 of 3 : UCIP\_SP\_2020\_21127\_35657.jpg

WS view: U typed concrete headwall and channel on waterside.

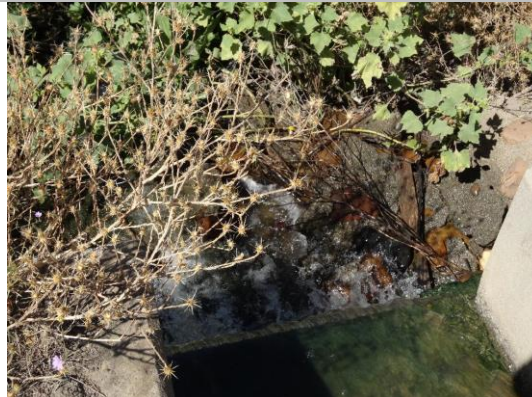
Photo 2 of 3 : UCIP\_SP\_2020\_21127\_35656.jpg

WS view: concrete headwall and concrete spillway on waterside.

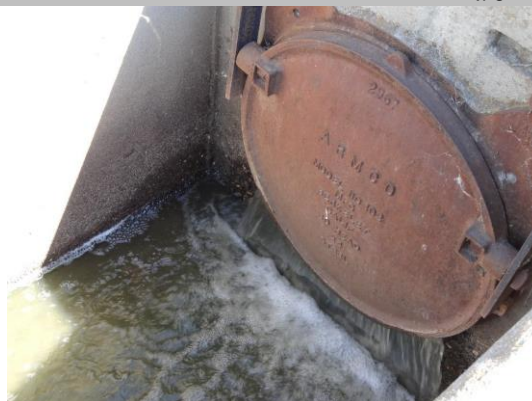
Photo 3 of 3 : UCIP\_SP\_2020\_21127\_35655.jpg

WS view: U typed concrete headwall, CM pipe, and flap gate. Drainage was working during survey.

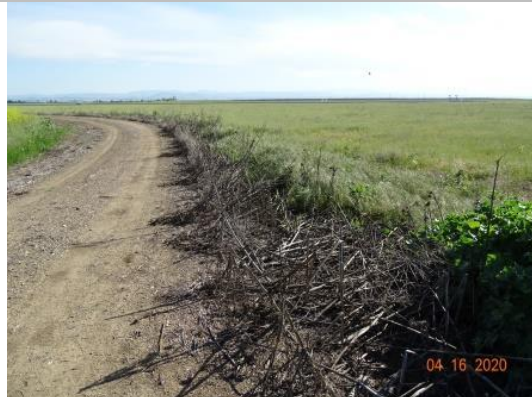
Photo 1 of 1 : SP\_2020\_NA0013\_334\_13\_20200505\_00034.jpg

LM Start	1.08	Rating **	U	Issue No.	13
LM End	1.41	Issue Type +	Ma	Location *	LS
Category	Earthen Levee			GPS Latitude/Longitude	
				Start	End
Item	Vegetation			37.262167 °	37.257437 °
				-120.288150 °	-120.288184 °
DWR ID	DWR_NA0013_04_s_2020_13				
Comment Code					
V1 : Control annual grass and weeds on the levee slopes and easements.					
Inspector Comment

View of vegetation growing along the landside slope. (Spring 2020)
